RE: Site Inspection, Quality Building Stone, Martin Quarry, S/007/037 (Unpermitted), Carbon County, Utah

Quality Building Stone, Martin Quarry

S/007/037

**Photographs
S/007/037
Martin Quarry**

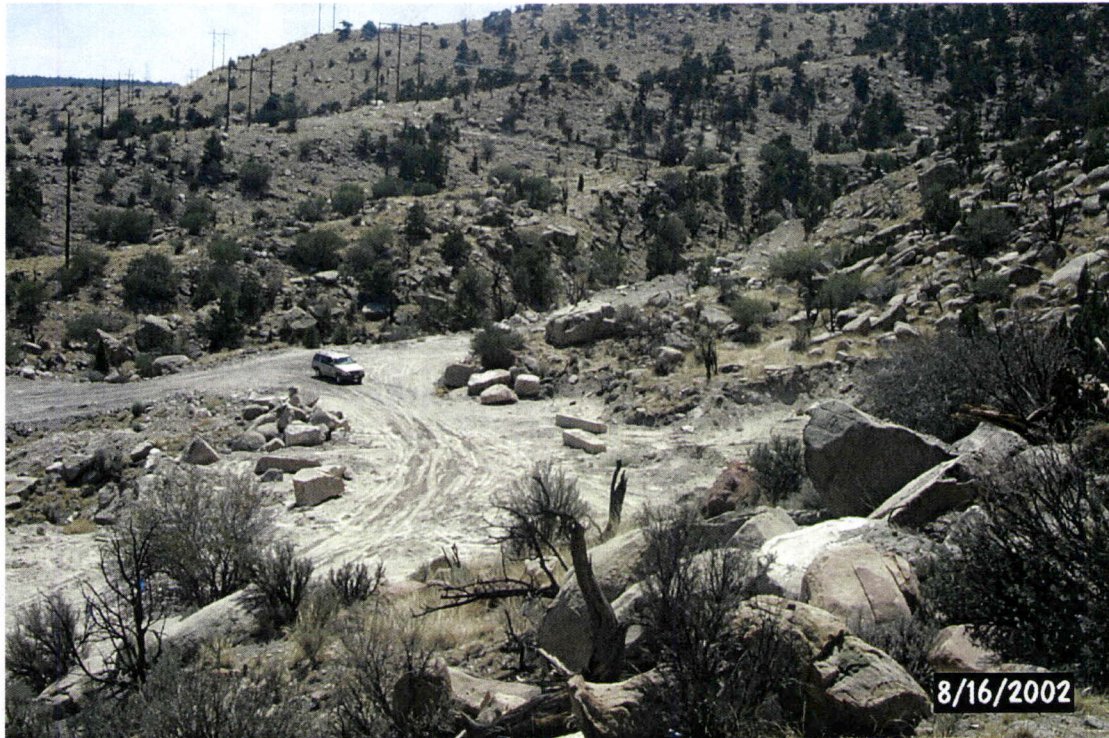
The overall site is shown from different aspects in Photos 1 and 2 in the attached document.

Photo 1. Overview of a portion of the site.

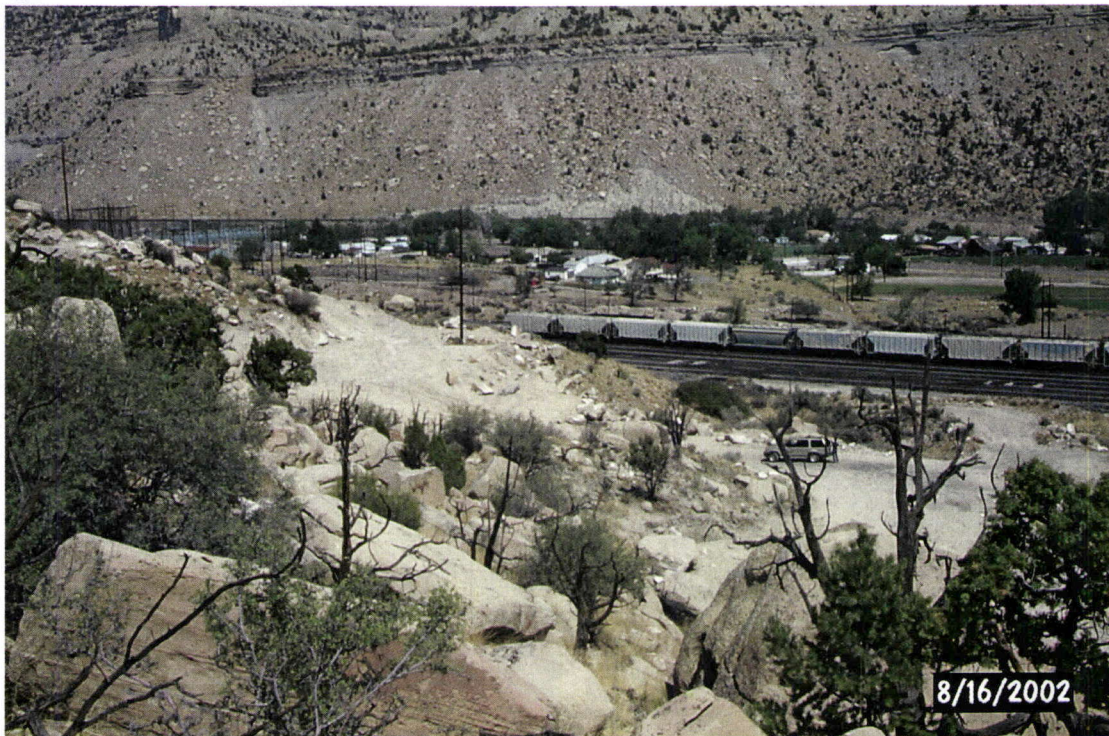
Photo 2. Overview of a portion of the site.

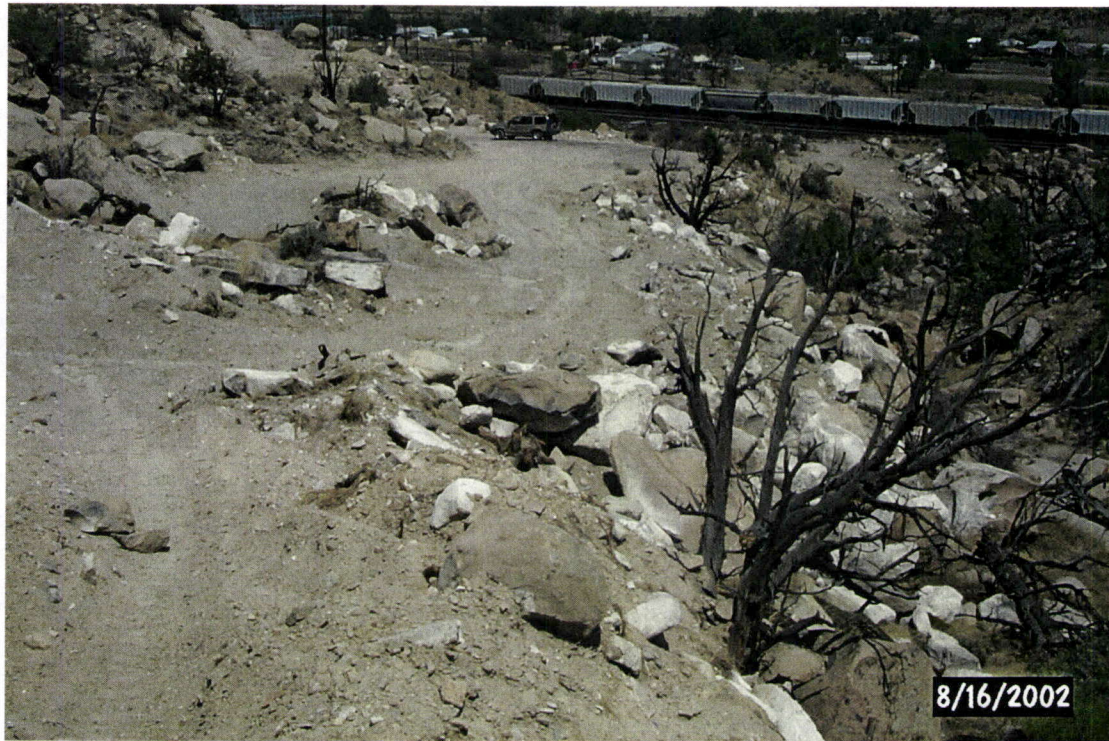
The disturbance mainly consists of areas where the soil and rock were pushed aside to create pad and road areas. Some of this material was pushed into the side of a drainage (Photo 3). We assume that some rock has been removed. Some of the rock showed evidence of being cut (Photo 4). There were no active operations at the time of the inspection.

Photo 3. Material pushed into the side of an adjacent drainage.
